LAKE GORDON DAM, (NDS-242), 11

PHASE I INSPECTION REPORT

BERGER ASSOCIATES, INC
CONSULTING ENGINEERS
HARRISBURG, PA.

Name of Dam: LAKE GORDON DAM
State and State Number: PENNSYLVANIA - 5-1
County: BEDFORD
Stream: EVITTS CREEK, POTOMAC RIVER BASIN
Date of Inspection: APRIL 25, 1978

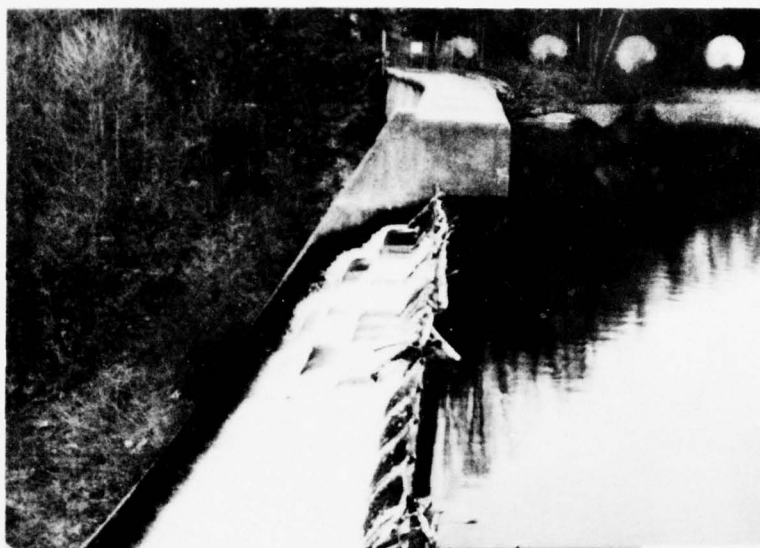
Upstream Face of Dam

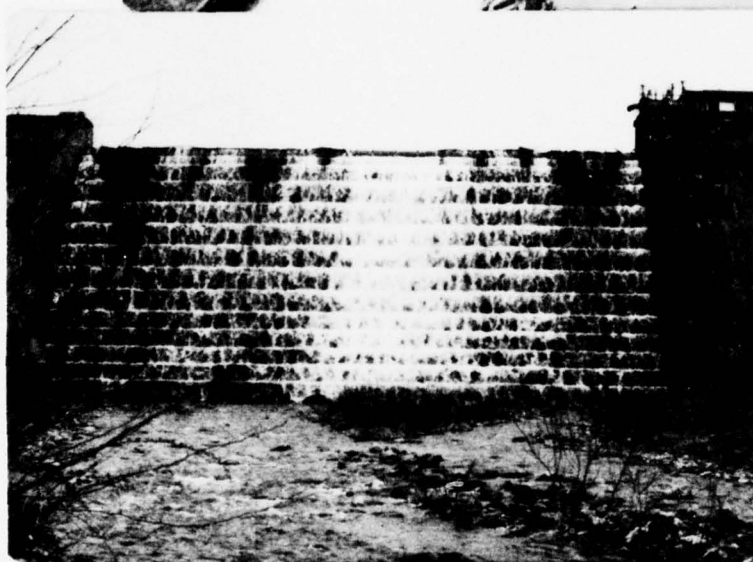
leakage through the dam. Only the boards were removed and, at the present time, the spillway crest is obstructed by horizontal 3 inch high x 8 inch wide planks which are bolted to the crest by the vertical flashboard pins, which are inserted in holes drilled in the spillway crest, and by miscellaneous drift which catches on the pins. The above items reduce the hydraulic efficiency of the spillway opening and it appears that they should be removed.

Spillway
Looking Westward

1. In order to improve the spillway capacity the owner should immediately remove the obstructions on the spillway crest (pins and 3 inch by 8 inch boards). It should be noted that the spillway will still be seriously inadequate after the crest is restored to its original condition.
2. Studies outlined under Paragraph 7.1.d should be initiated immediately and completed within an acceptable time frame.

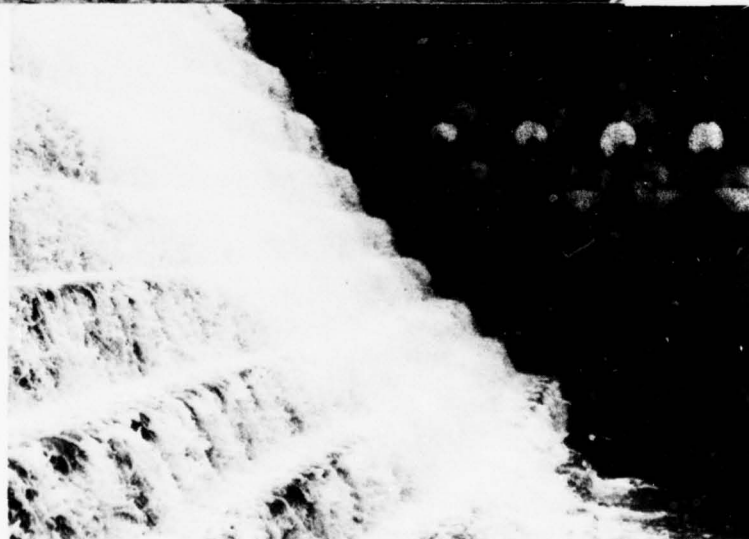
Spillway

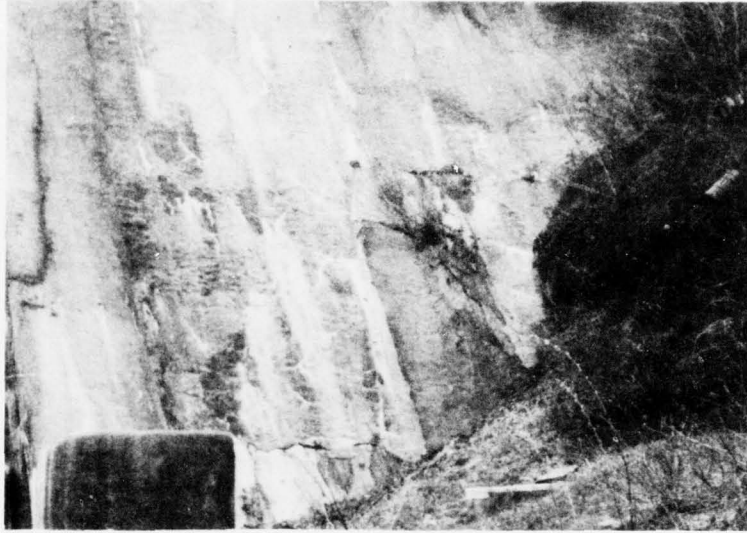
PLATE IV

There is considerable cracking of the gunite surface on the downstream face of the dam, but this cracking seemed to be caused by shrinkage rather than resulting from internal dam stresses, or settlements and movements. The gunite prevented observation of the original dam surface and it was not possible to make conclusions on the condition of joints. A bush is growing on the left abutment of the dam surface. The spillway surface could not be inspected due to the amount of water falling over the steps.

Steps in
Spillway

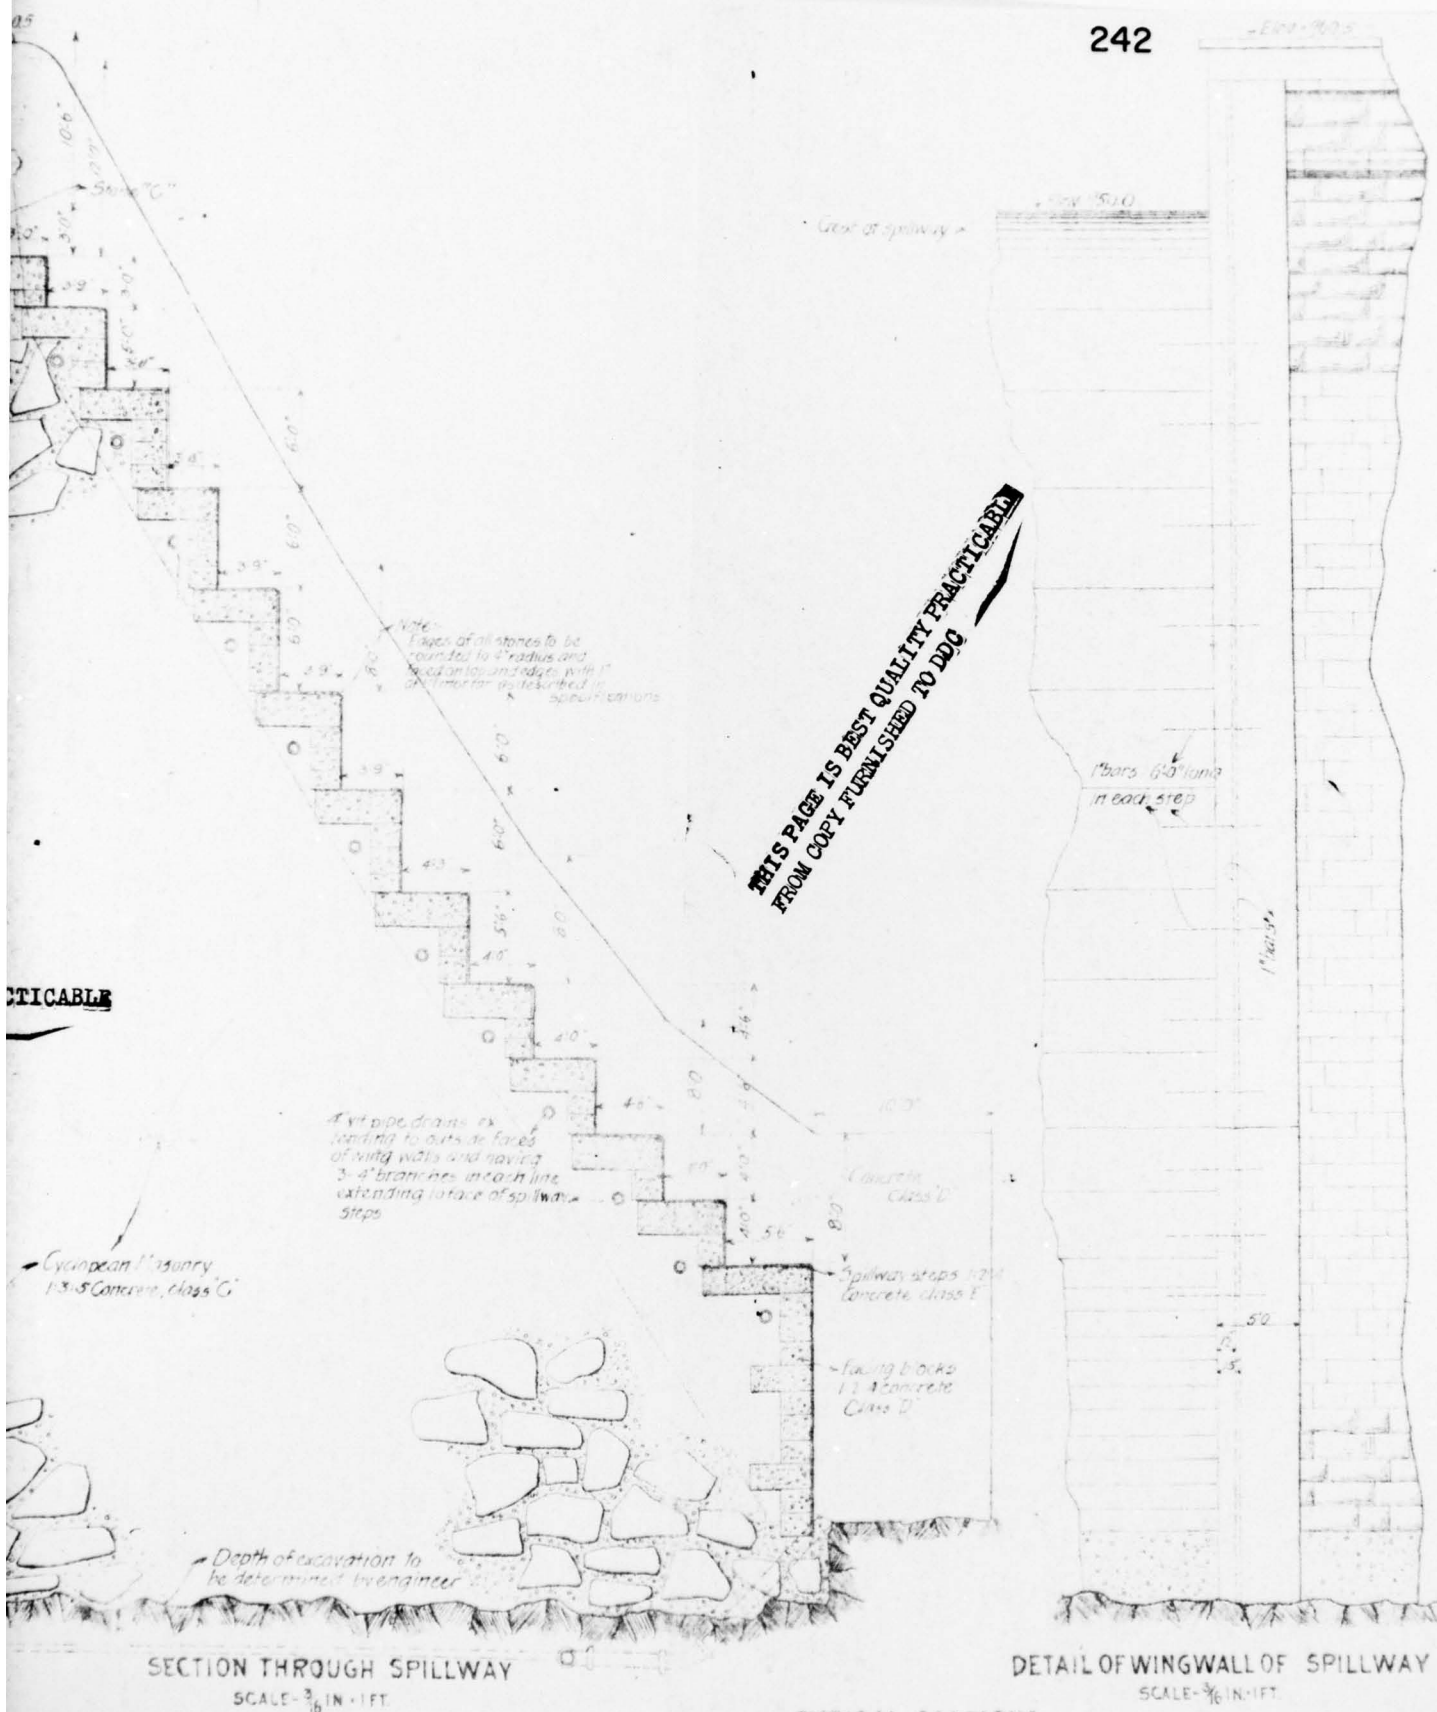
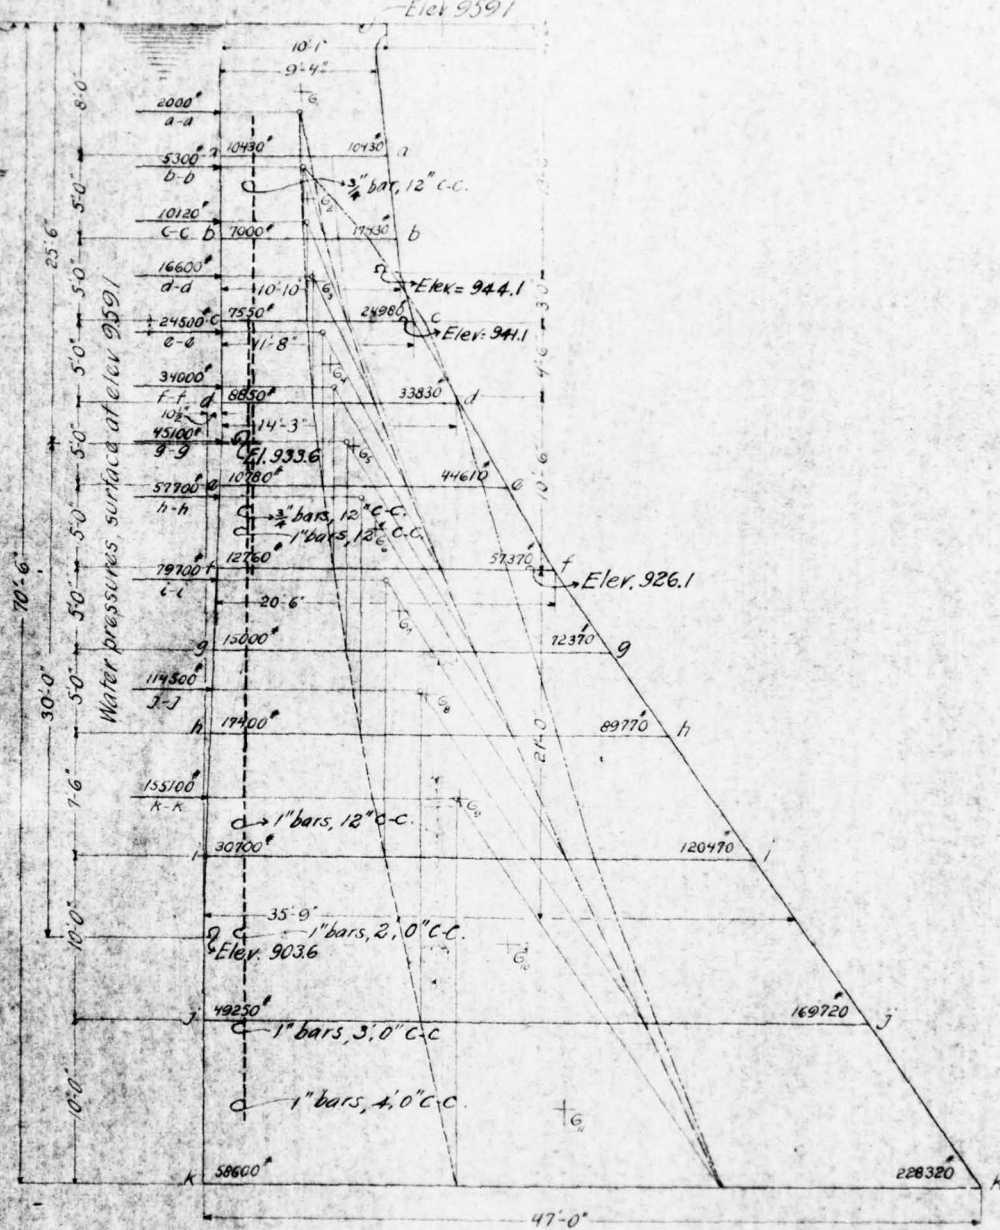
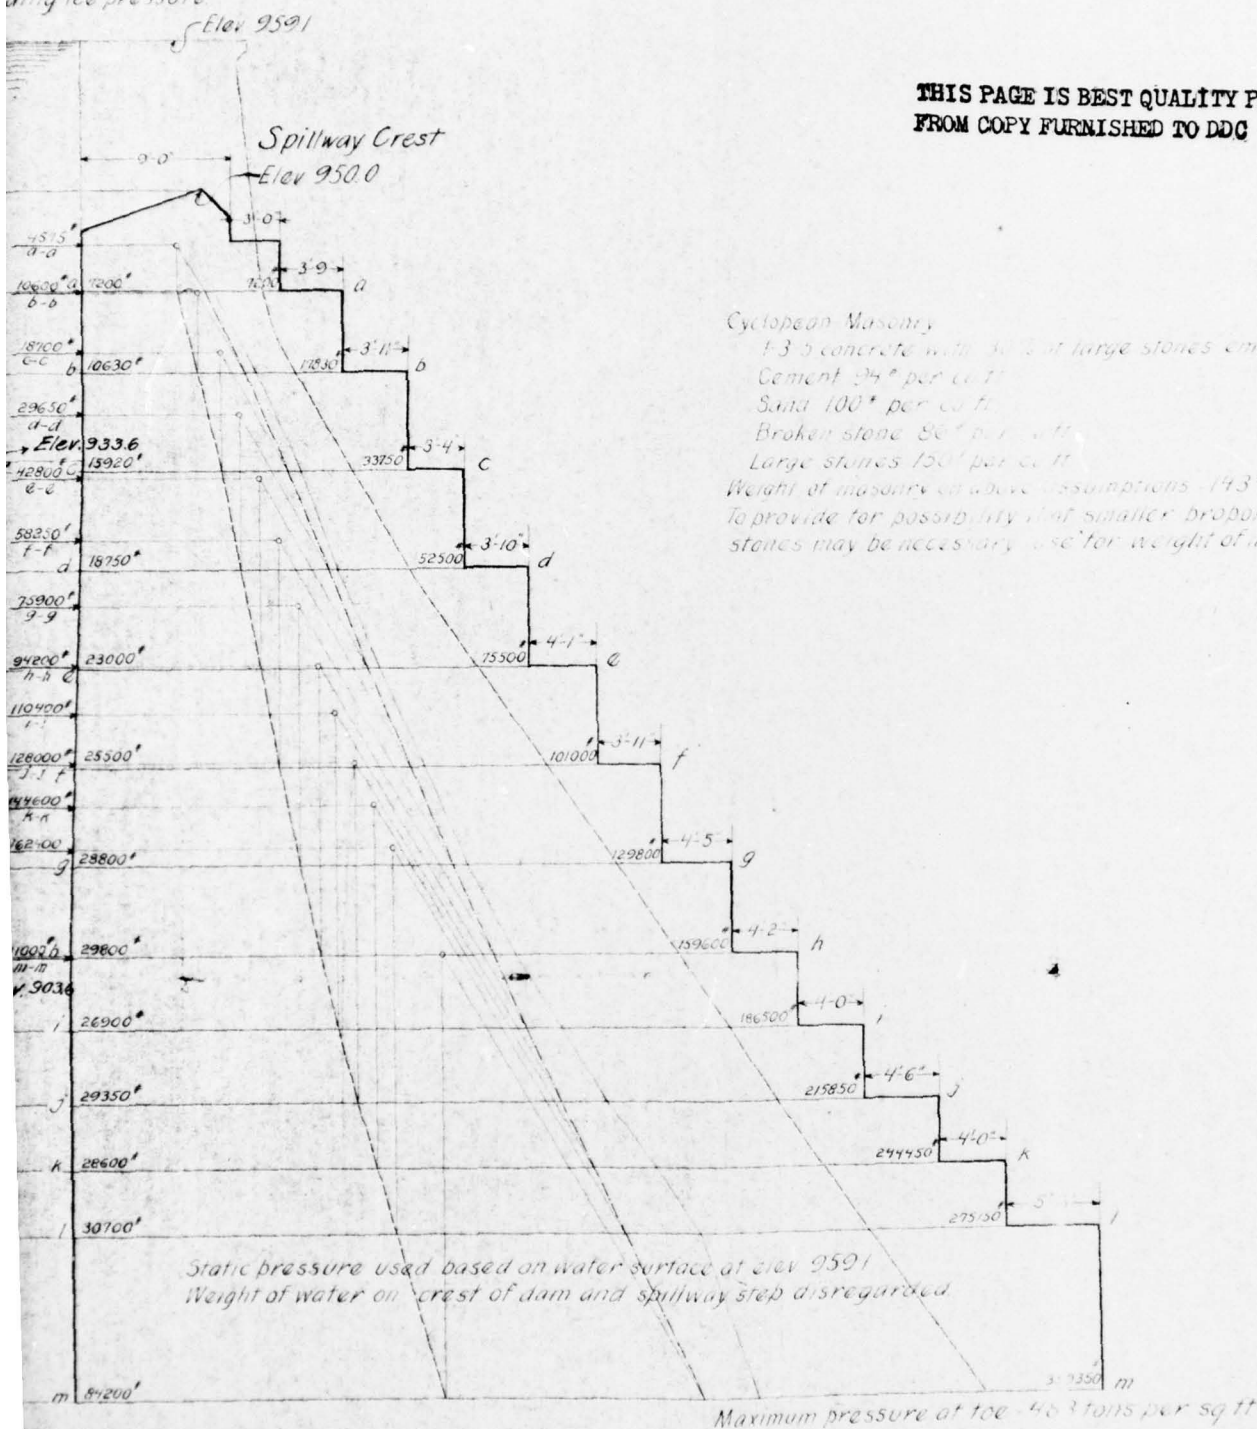
Appendix D, Plate X, indicates the loci for different loading conditions with a maximum pool elevation of 959.0. In Appendix C, approximate calculations have been made for an assumed pool elevation of 963.0 or four feet above the top of the dam. At this elevation, approximately 50 percent of PMF would pass.

The calculations indicate that the resultant force does not fall within the middle third of the foundation. The factor of safety against overturning and sliding seems to be adequate. However, these results are based on no uplift as in the original plans. The actual condition of the foundation and the functioning of the foundation drain is vital information required to evaluate the structural stability of this dam. If uplift would be present, the factor of safety against overturning could be nonexistent.

There is at present not sufficient information available to review all design criteria for this dam under pool levels higher than the design pool level of 959. Additional information is required on the foundation rock strata and the foundation underdrain. The collection of this information and a detailed stability analysis should be a part of further investigation.

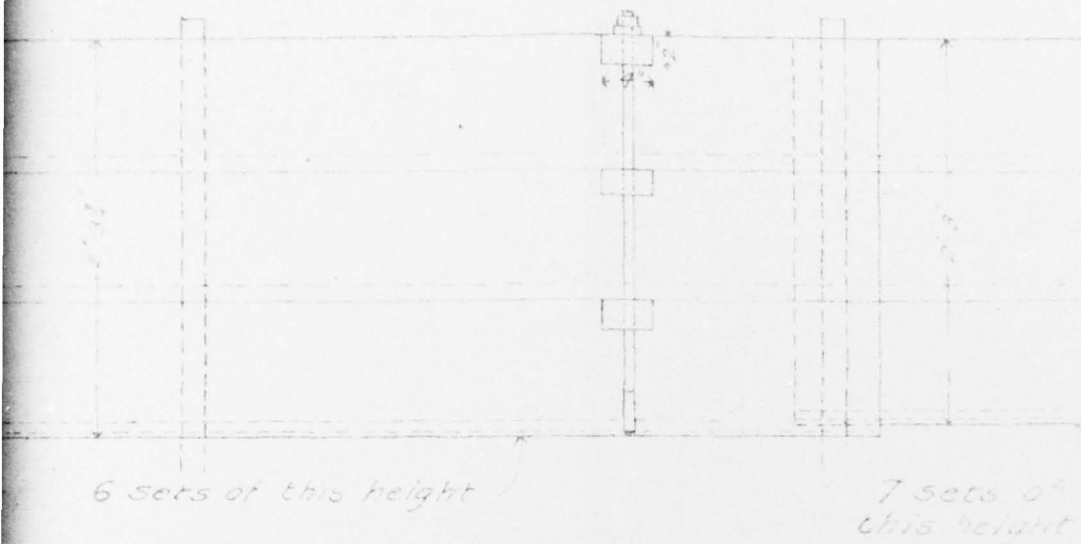
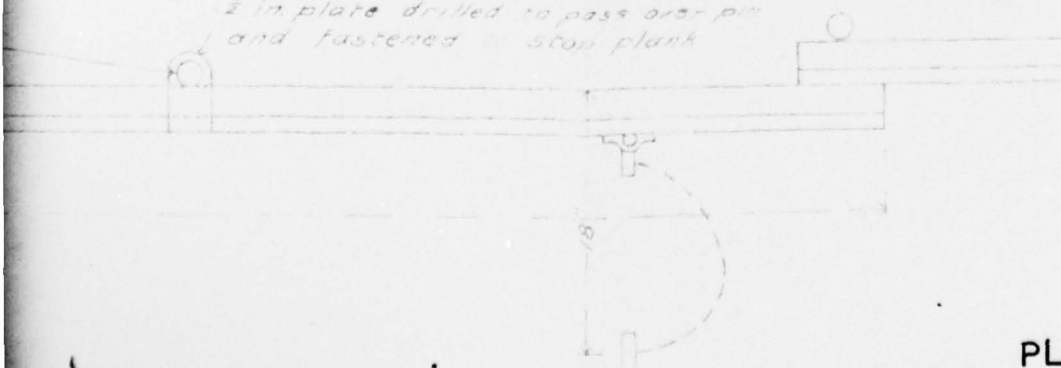
EVITTS GREEK WATER COMPANY
 DETAIL OF FLASH BOARDS FOR
 DAM AT LAKE GORDON

In 1927, approval was given for the installation of a 24 inch high flashboard, which was supposed to break if the water were to rise to 18 inches above the flashboards. Time of actual installation is not known. The flashboards caused a considerable increase in leakage at the abutments and as a result they were removed in 1977.

At one time in the past, the spillway crest of this dam was provided with two-foot-high flashboards. These flashboards were subsequently removed because the higher pool elevation caused excessive
